Manhole Inspection Summary

Manhole # S03SS1018MH

Insp Date: **9/11/08 1:17 PM**

Location Address: **5601 MAGNOLIA AVE**

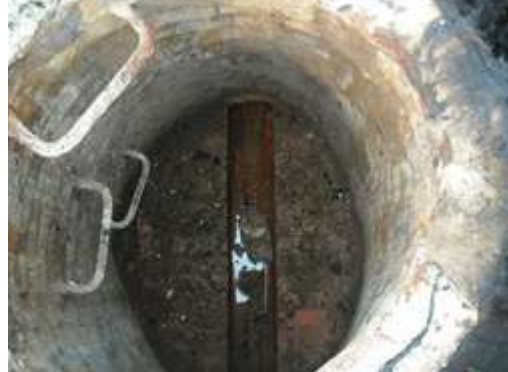
Top View

Evidence of surcharge - Bench debris.
Channel debris.

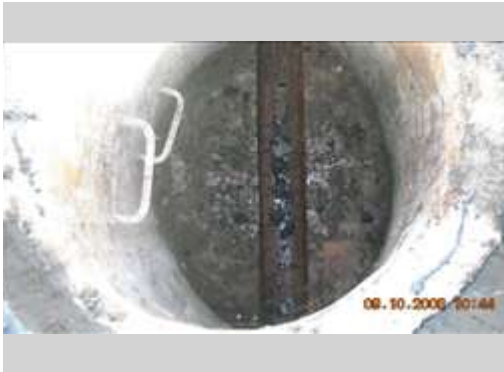
Defect

Frame offset. Adjustment deterioration
and infiltration. Corbel and Barrel
infiltration.

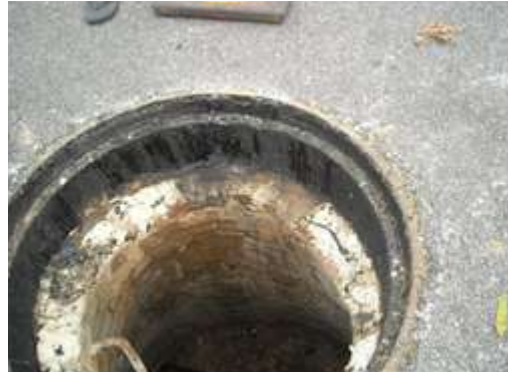
Defect

Frame offset. Adjustment deterioration
and infiltration. Corbel and Barrel
infiltration.

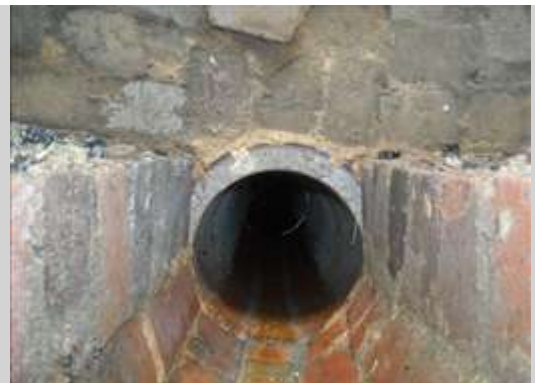
Pipe Out @ 12 O'Clock

Pipe Material: **Clay** ☐ Pipe Lined

Invert Depth: **6.31** (ft.) Flow Characteristics: **None**

Deposits: ☒ None ☐ Mud ☐ Sludge ☐ Debris ☐ Grease

Infiltration: **None** Pipe Seal Cond: **Unknown**

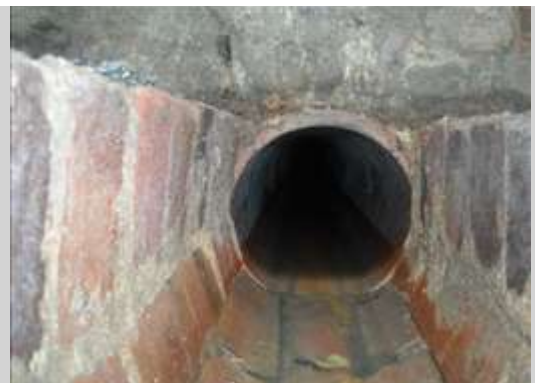
Pipe In @ 6 O'Clock

Pipe Material: **Clay** ☐ Pipe Lined

Invert Depth: **6.23** (ft.) Flow Characteristics: **None**

Deposits: ☒ None ☐ Mud ☐ Sludge ☐ Debris ☐ Grease

Infiltration: **None** Pipe Seal Cond: **Unknown**
